GTI Laboratories
1700 S. Mt. Prospect Road
Des Plaines, Illinois 60018

**Static Discharge Failure of PE Pipe
for
Connecticut Natural Gas Corp.**

May 5, 2003

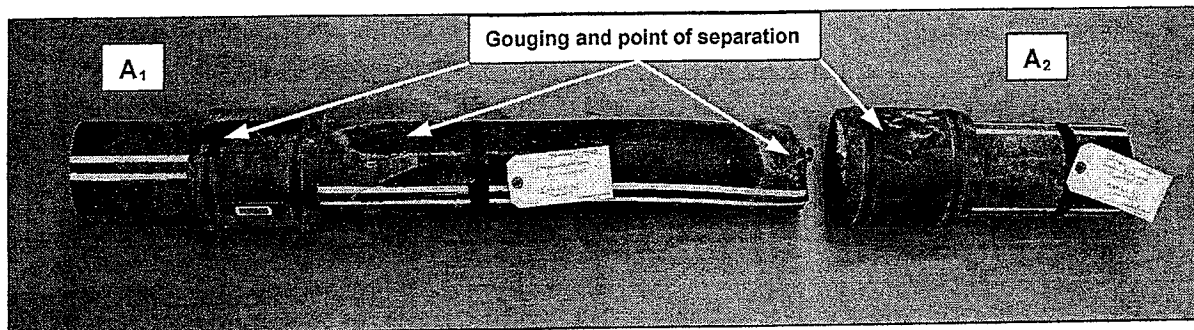
Fig. 2. Samples A₁ (left) and A₂ (right) as received. Severe mechanical damage/gouging from a 3rd party excavator can be seen along the length of the pipe (see arrows above).

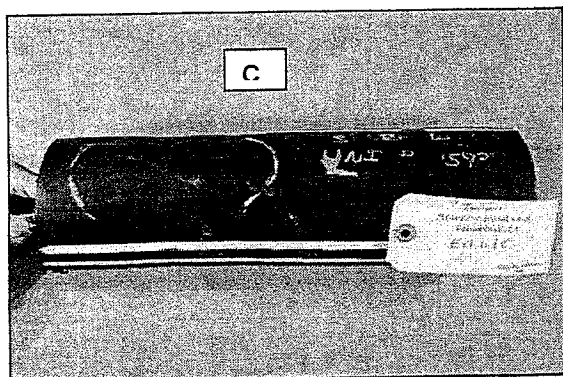
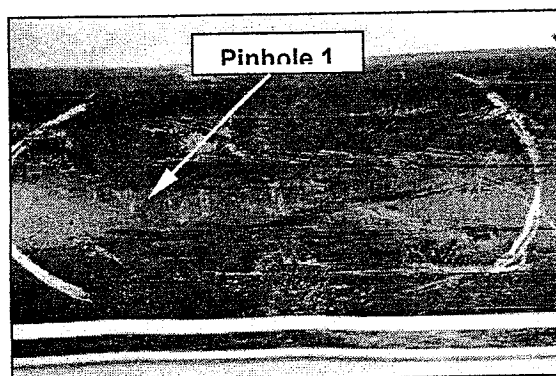
Fig. 3. Sample C as received (a) and close-up of area (b) with general location of pinhole 1 as determined by a soap bubble leak check.

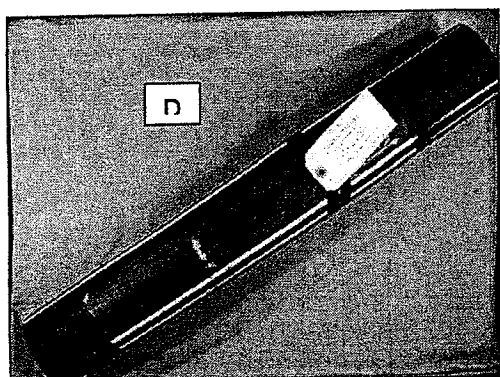
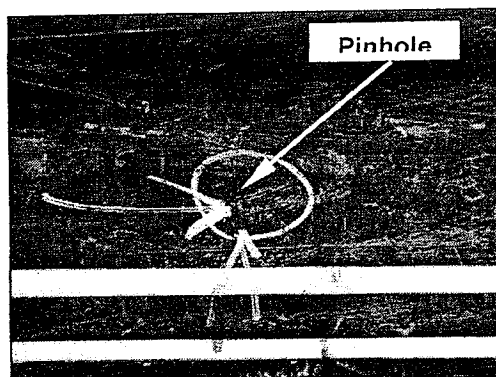
Fig. 4. Sample D as received (a) and close-up of area (b) with general location of pinhole 2 as determined by a soap bubble leak check.

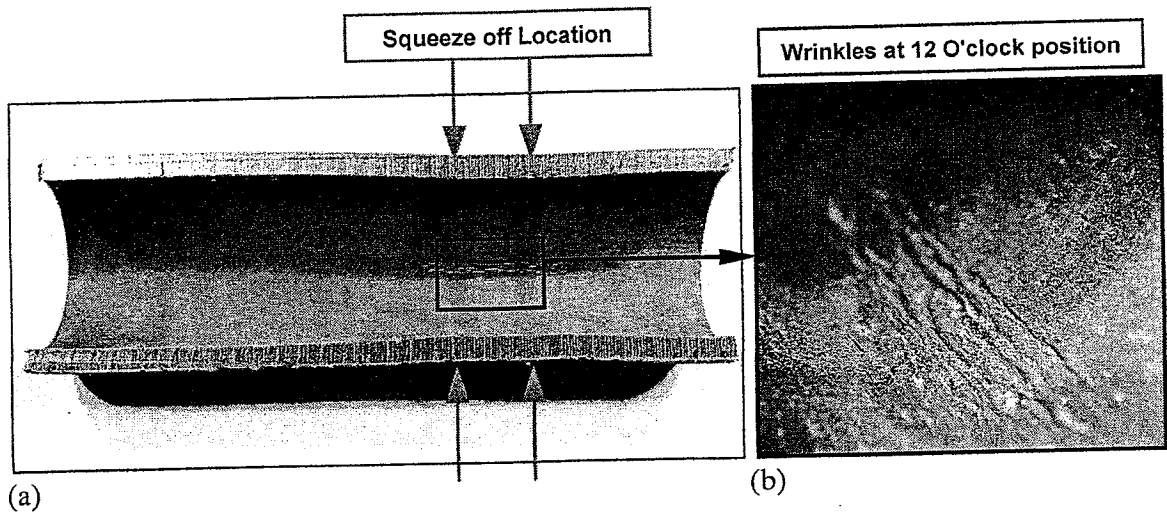
Fig. 6. Picture of squeeze off area (a) showing the squeeze direction with red arrows. The blue box highlights the wrinkles at the 12 O'clock position on the pipe (b).

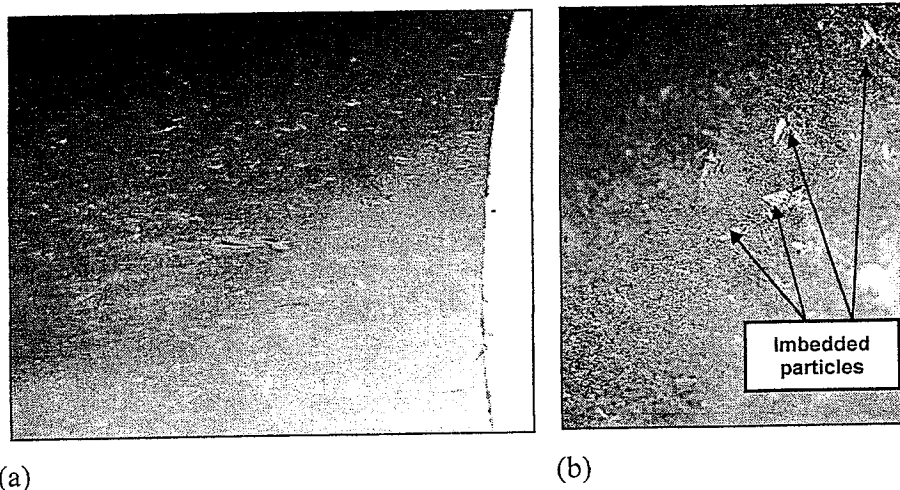
Fig. 7. Downstream impingements of debris into the pipe wall (a). Higher magnification (b) shows actual particles partially imbedded into the pipe wall.

4. If this particular system has a large amount of debris (e.g., fine corrosion products from metal components) in the gas stream, then the use of filtering or anti-static devices might be considered.

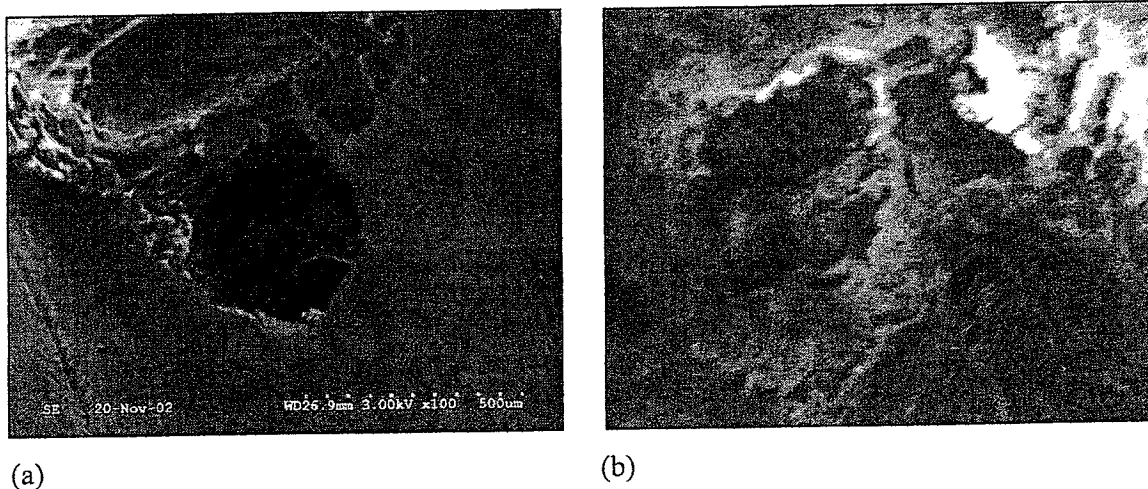
Pinhole 1, in sample C, was found at the location of the squeeze-off. The pinhole was in the wrinkles made in the plastic by the squeeze-off tool. Images of the pinhole are shown in Figs. 9 and 10 below.

Fig. 9. SEM micrographs of pinhole 1 in sample C on the (a) inside surface and (b) outside surface.

Pinhole 1 has a clean, single entry point on the inner surface of the pipe wall. The size is between 400-500 microns. The exit point is much less well defined but resolvable. As will be shown with the other pinhole, there was branching of the arc path through the pipe wall. This is typical for a discharge resulting from a high voltage event producing an electric field greater than the dielectric strength of the material.

If one assumes that the dielectric strength of the polyethylene is 450 V/mil, and a pipe thickness of 0.409 inches (409 mil) then the required voltage to reach the dielectric strength is:

$$450 \text{ V/mil} \times 409 \text{ mil} = \underline{184,050 \text{ volts}}$$

2. However, the use of a bypass line, with a controlled packing (re-pressurizing) of the repaired line would have allowed both sides of the squeeze off to be equalized prior to release of the tool. This would have greatly reduced the velocity upon relaxation of the squeeze off tool. The lower velocity would generate less static charge on the interior surfaces of the pipe wall (less gas flow and friction), therefore reducing the chance of a discharge event from the inside of the pipe to the outside.

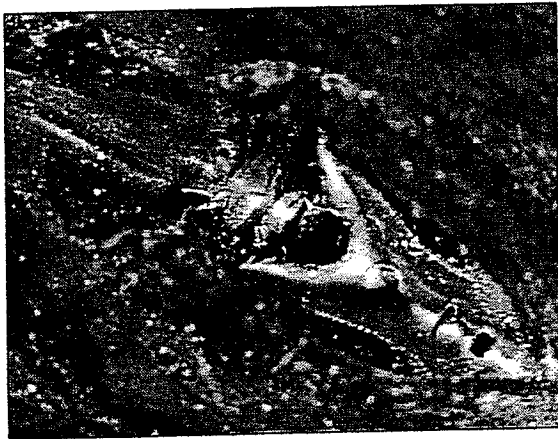
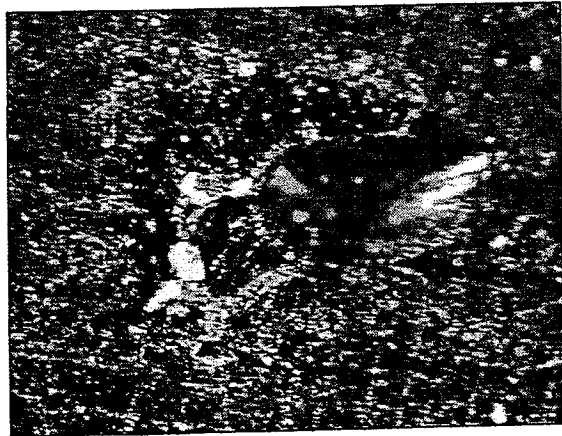
Pinhole 1 is also shown in Fig. 10. These stereo-optical micrographs clearly show the interior pinhole and signs of localized melting at the entry point of the pinhole to the pipe wall. This smooth, melted surface is typical of high voltage discharge events on the inside of through pipe wall events.

Fig. 10. Stereo-optical micrographs of pinhole 1 (see Fig. 9) in sample C. (a) Entry point of pinhole on the inside surface, note the evidence of localized melting around the hole. (b) The outside surface is not nearly as well defined and shows evidence of branching.

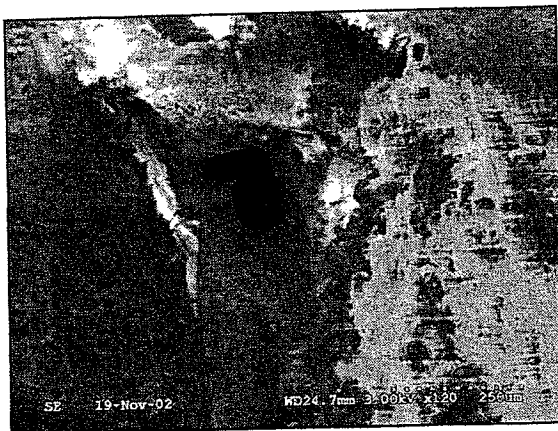
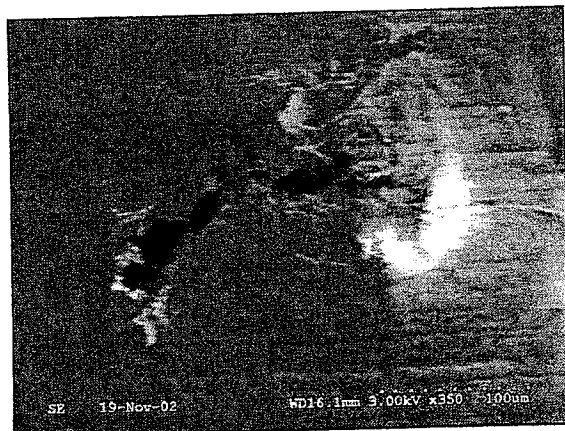
Pinhole 2, in sample D, was found in a portion of the pipe that was *upstream* from the squeeze-off point and pinhole 1. It is suspected that a pipe locator wire, approximately 1 inch below the pipe, played a role in the static discharge and subsequent formation of pinhole 2.

Fig. 11. SEM micrograph of pinhole 2 in sample D: (a) Single entry point on the inside surface and (b) branched exit site on the outside surface.

3. The second pinhole was most likely caused by the close proximity of the tracer wire (a ground source for the built up static charge). The tracer wire was located approximately 1 inch from the pipe where the pinhole was found. This wire represents a grounded electrical conductor in close proximity to the pipe wall. Its interaction with the local electric fields increases the chance of discharge through the pipe wall to the grounded wire. Standard procedures dictated that the wire should be 6 inches from the pipe. The use of "tracer wire spacers" should be considered for installations where tracer wire placement is hard to control.

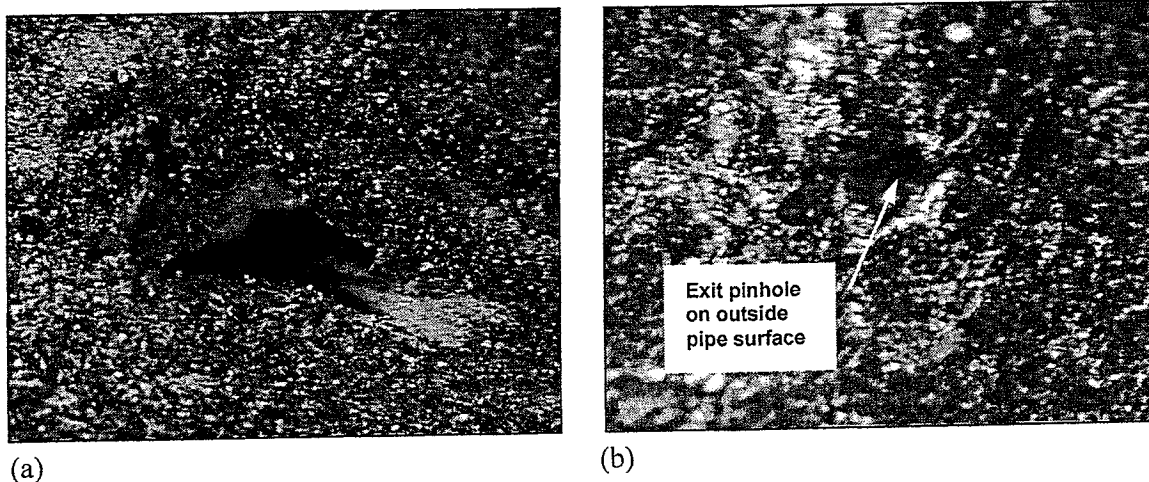
CNG Construction Standards state that tracer wire should be 6 inches below plastic pipe separated by 6 inches of stone-free sand. The pinhole can be seen in Figs. 11 and 12 below.

Fig. 12. Stereo-optical micrographs of pinhole 2 in sample D: (a) Non-symmetric entry point on inside surface and (b) exit site on the pipe wall outside surface. A tracer wire (metal conductor) was located approximately 1 inch from the exit site and represented a potential ground path.
