Electrostatic Pinholing in PE Service Lines

By Ray A. Ward, Gas Systems Engineer, Memphis Light Gas and Water and Dirk Smith, President, Ionix Technologies Inc.

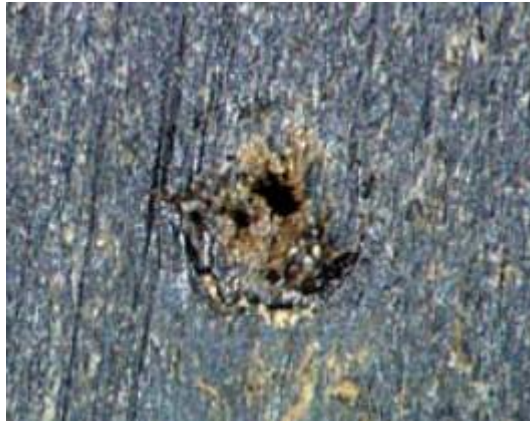
Investigation by the pipe manufacturer revealed numerous pinholes throughout the damaged pipe. Sectioning the pipe under a light microscope the pipe manufacturer documented a channel through the pipe wall. The pipe samples were section cut under a microscope. The shape or characteristic of the pinhole channel was consistent with electrostatic pinholing.

Interior pinhole of damaged pipe

Based upon their investigation, the pipe manufacturer determined the probable cause of the pinholing was electrostatic discharge. The manufacturer's test lab concluded that during the filling of the pipe with air for pressure testing and the resulting release of the air at the end of the test, the volumes and velocity of the air and the condition of the air, (i.e. sometimes referred to as dirty air) resulted in the buildup of a static charges that exceeded the dielectric strength of the material thickness found in the wall of a 1 inch pipe. With a 0.122 inch nominal wall thickness and a dielectric strength of 510 V/mil, the voltage that was necessary to cause the resulting pinholes were calculated to be a minimum of 62,220 volts! For comparison purposes, approximately 2000 volts will ignite a gaseous mixture. Performance Pipe found dirt clogging the pinholes of the damaged pipe indicating dirt was present in the pipe at the time pinholing occurred.

Electrostatic pinholing can be an expensive problem. PE pipes with pinholes must be replaced since they cannot be repaired. Since the damage in this event was due to the electrostatic discharge of the pipe, the contractor was not held liable. Therefore MLGW absorbed the cost of \$3,641.92 for the replacement of the line.

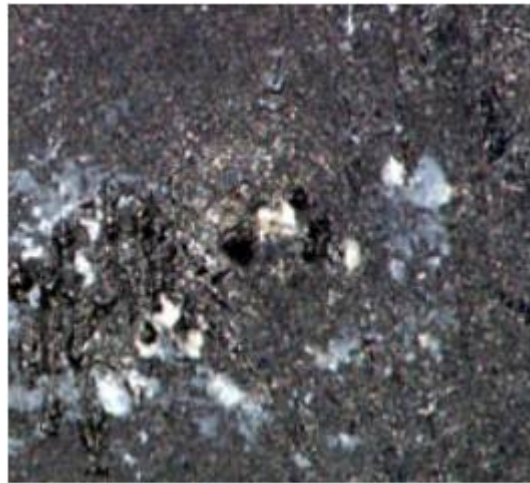
Exterior pinhole of damaged pipe

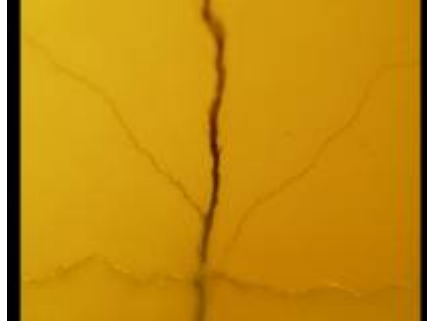
The second distinctive of the morphology is the shape of the channel. The channel will be tree shaped with branching. There will rarely be a direct channel through the pipe wall and the channel will become smaller as the charge diminishes.

Typical channel of electrostatic discharge
