Electrostatic Pinholing in PE Service Lines

By Ray A. Ward, Gas Systems Engineer,
Memphis Light Gas and Water and
Dirk Smith, President, Ionix Technologies Inc.

This article will document a case of pinholing in PE natural fuel gas distribution pipe that has significant implications for local distribution companies (LDCs).

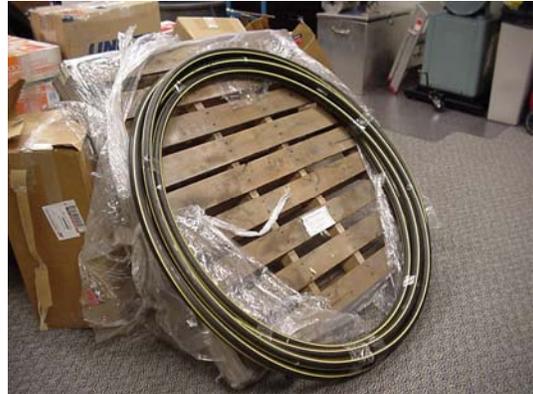
Investigation by the pipe manufacturer revealed numerous pinholes throughout the damaged pipe. Sectioning the pipe under a light microscope the pipe manufacturer documented a channel through the pipe wall. The pipe samples were section cut under a microscope. The shape or characteristic of the pinhole channel was consistent with electrostatic pinholing.

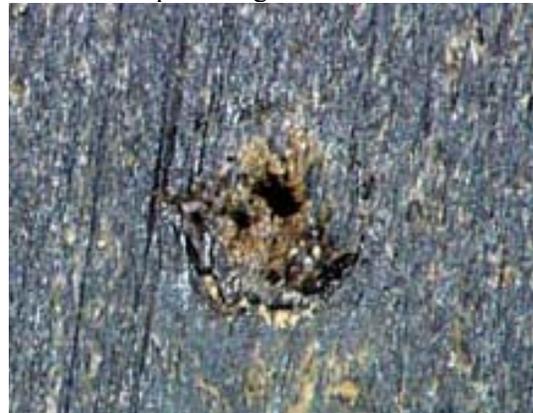
Interior pinhole of damaged pipe

Based upon their investigation, the pipe manufacturer determined the probable cause of the pinholing was electrostatic discharge. The manufacturer's test lab concluded that during the filling of the pipe with air for pressure testing and the resulting release of the air at the end of the test, the volumes and velocity of the air and the condition of the air, (i.e. sometimes referred to as dirty air) resulted in the buildup of a static charges that exceeded the dielectric strength of the material thickness found in the wall of a 1 inch pipe. With a 0.122 inch nominal wall thickness and a dielectric strength of 510 V/mil, the voltage that was necessary to cause the resulting pinholes were calculated to be a minimum of 62,220 volts! For comparison purposes, approximately 2000 volts will ignite a gaseous mixture. Performance Pipe found dirt clogging the pinholes of the damaged pipe indicating dirt was present in the pipe at the time pinholing occurred.

Electrostatic pinholing can be an expensive problem. PE pipes with pinholes must be replaced since they cannot be repaired. Since the damage in this event was due to the electrostatic discharge of the pipe, the contractor was not held liable. Therefore MLGW absorbed the cost of \$3,641.92 for the replacement of the line.

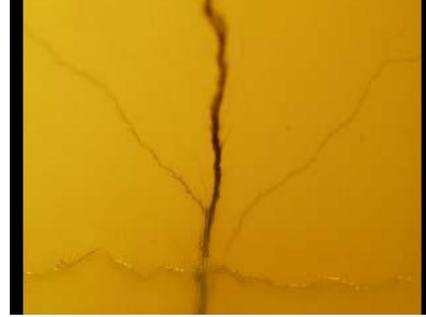
The morphology of channels caused by electrostatic discharge are distinctive in 2 aspects. First, the diameter of the pinholes on the inside and outside will be different. One pinhole will be substantially larger than the other. This is because the electrostatic voltage charge is higher one side of the pipe wall than the other. When discharge occurs and the voltage drops, the heat from the static declines and the final exit hole diameter is smaller. The larger hole indicates where the charge started and the small hole indicates where it ended.

The second distinctive of the morphology is the shape of the channel. The channel will be tree shaped with branching. There will rarely be a direct channel through the pipe

wall and the channel will become smaller as the charge diminishes.

Typical channel of electrostatic discharge
