Electrostatic Pinholing Can Cause Serious Problems For LDCs

by **Ray A. Ward**, Gas Systems Engineer, **Memphis Light, Gas and Water** and **Dirk Smith**, President, **Ionix Technologies Inc.**

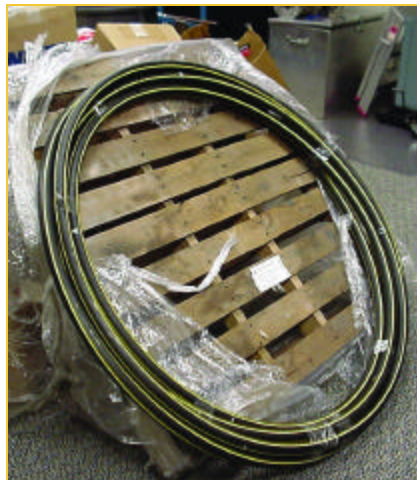
Although the pipe was never in service, the PE pipe service line failed to hold pressure. The pipe was removed from the ground and returned to the manufacturer for inspection and testing where tests revealed the pinholes were caused by electrostatic discharge while the PE pipe was buried underground and not in service. This article will review the probable cause of this damage, what LDCs need to look for to determine if the pinholes are caused by electrostatic discharge (the morphology of pinholes) and the service implications for LDCs of electrostatic pinholing in PE pipe.

The pinholed pipe removed from the ground and coiled to be shipped back to Performance Pipe.

Based upon its investigation, the pipe manufacturer determined the probable cause of the pinholing was electrostatic discharge. The manufacturer's test lab concluded that during the filling of the pipe with air for pressure testing and the resulting release of the air at the end of the test, the volumes and velocity of the air and the condition of the air, (i.e. sometimes referred to as dirty air) resulted in the buildup of a static charges that exceeded the dielectric strength of the material thickness found in the wall of a 1-inch pipe.

With a 0.122-inch nominal wall thickness and a dielectric strength of 510 V/mil, the voltage that was necessary to cause the resulting pinholes was calculated to be a minimum of 62,220 volts. For comparison purposes, approximately 2,000 volts will ignite a gaseous mixture. Performance Pipe found dirt clogging the pinholes of the damaged pipe, indicating dirt was present in the pipe at the time pinholing occurred.

due to the electrostatic discharge of the pipe, the contractor was not held liable. Therefore, MLGW absorbed the cost of \$3,641.92 for the replacement of the line.
