# Static Electric Pinholing Through Polyethylene Pipe

MARK STAKER, Training Coordinator  
Mountain Fuel Supply Company

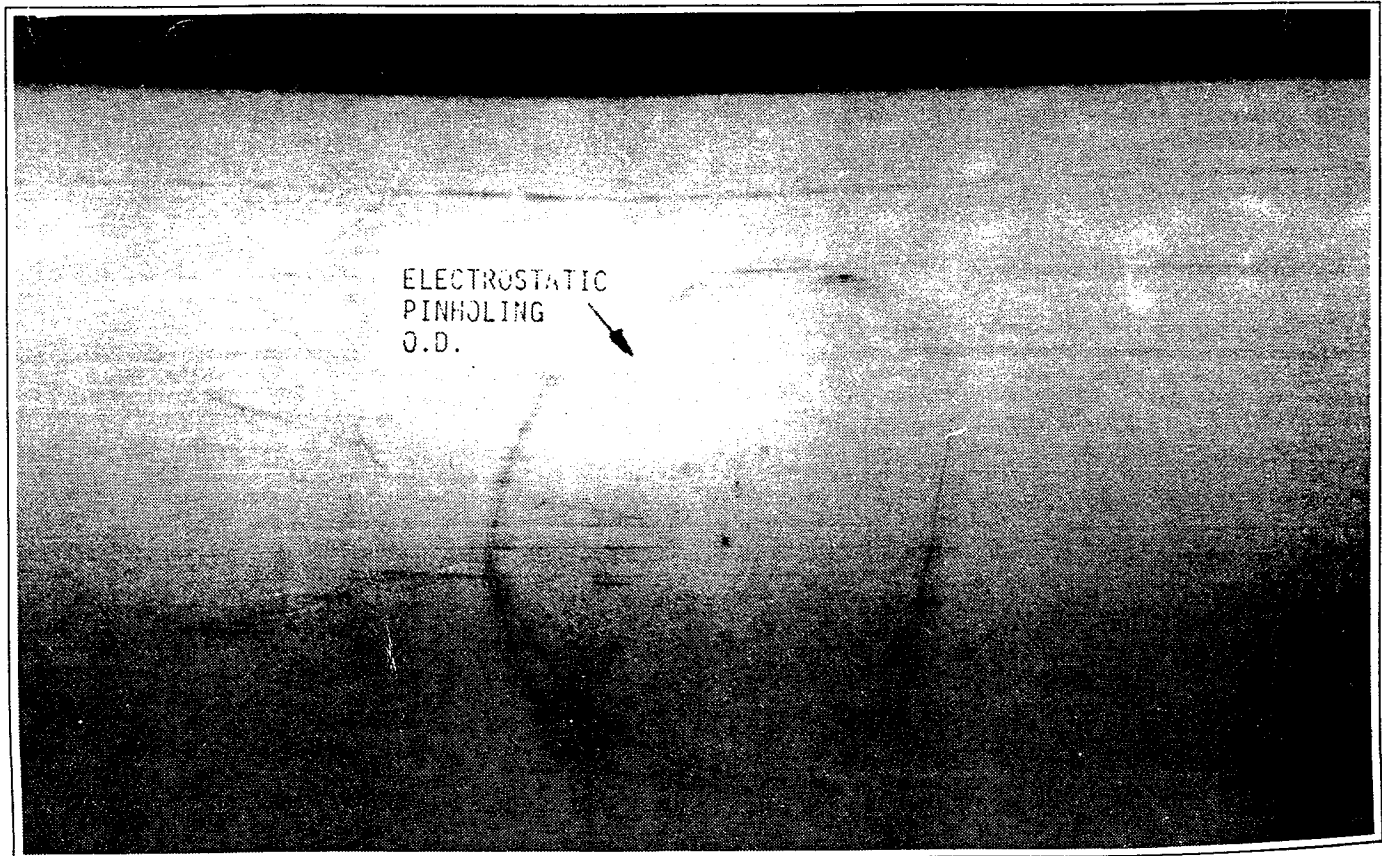
Closer examination of the failure revealed some small black dots (pinholes) that were leaking. Not fully understanding what had happened, our soaping of squeeze-off areas was emphasized. Field personnel were asked to look consciously for this pinholing leak. These efforts resulted in six pinholing squeeze-off failures reported in a two-week period, all of which were determined to be caused by static pinhole discharge. See Figures 1, 2, 3, and 4.

Figure 1. This 2" I.P.S. electrostatic pinhole occurred when purging a new piping system.

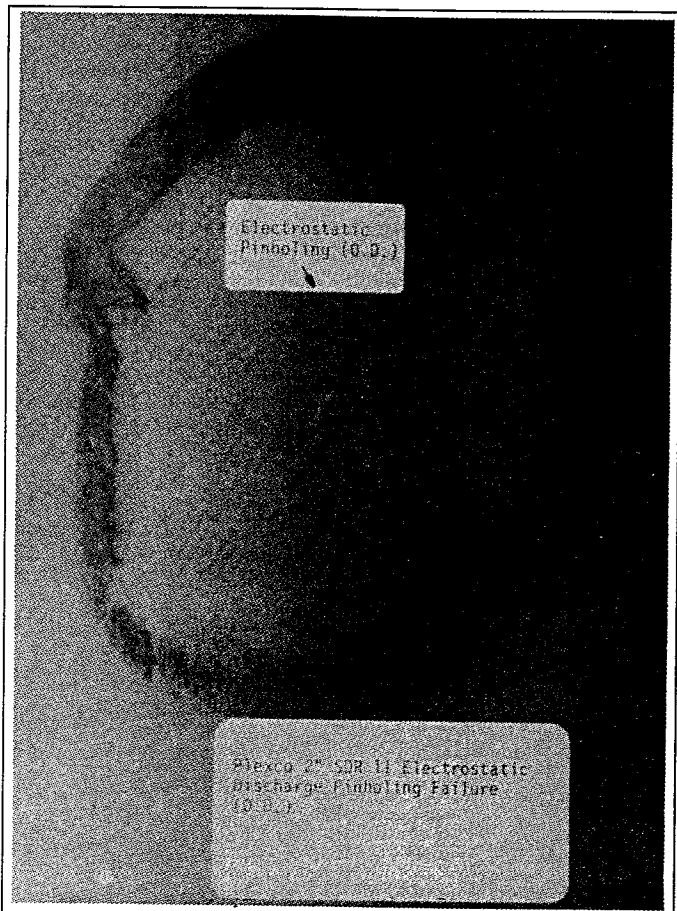
**Figure 2.** This 2" electrostatic pinhole occurred while filling a new piping system with natural gas.

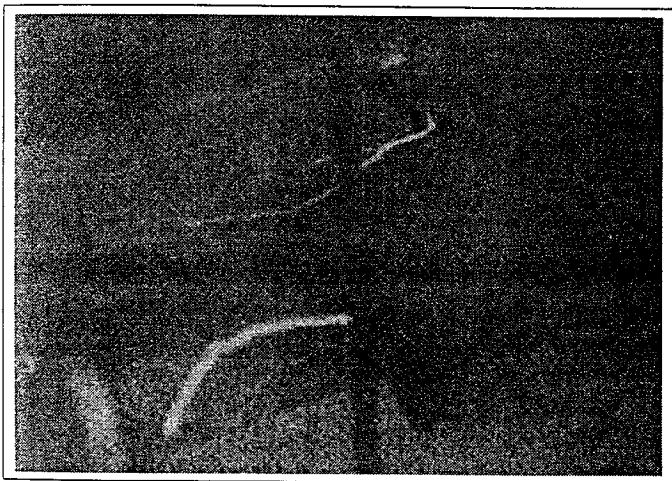
reached the inside of the pipe wall, a spark and cracking sound of a discharge was heard. This type of static discharge was recorded on video tape—see Figure 6. After experiencing this discharge, several more cuts were made in the pipe at various intervals. Small discharges were found in virtually every hacksaw cut. Some cuts were within three inches of another cut. The conclusion of this test is that a static charge that develops on the inside of the pipe does not dissipate very rapidly. We have been able to determine that a static charge can remain on the pipe wall for as many as twelve hours.

**Figure 6.** This static spark occurred while in the process of cutting into the pipe with a hacksaw. A static charge had been given to this test system approximately 15 minutes earlier.
