Topical Report

Analysis of Microscopic Leaks in Polyethylene Gas Distribution Piping

September 1996

REPORT DOCUMENTATION PAGE	1. REPORT NO. GRI-96/0014	2.	3. Recipient's Accession No.
4. Title and Subtitle Analysis of Microscopic Leaks in Polyethylene Gas Distribution Piping			5. Report Date September 1996

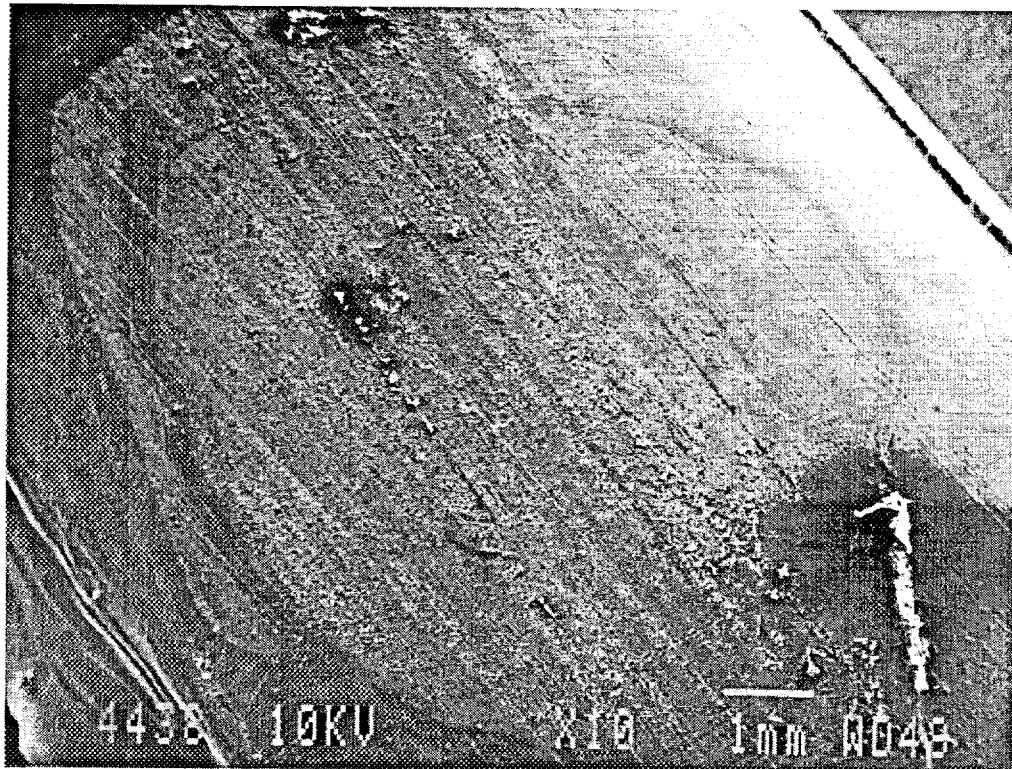
Figure 3. OD of Hamlin sample (10X)

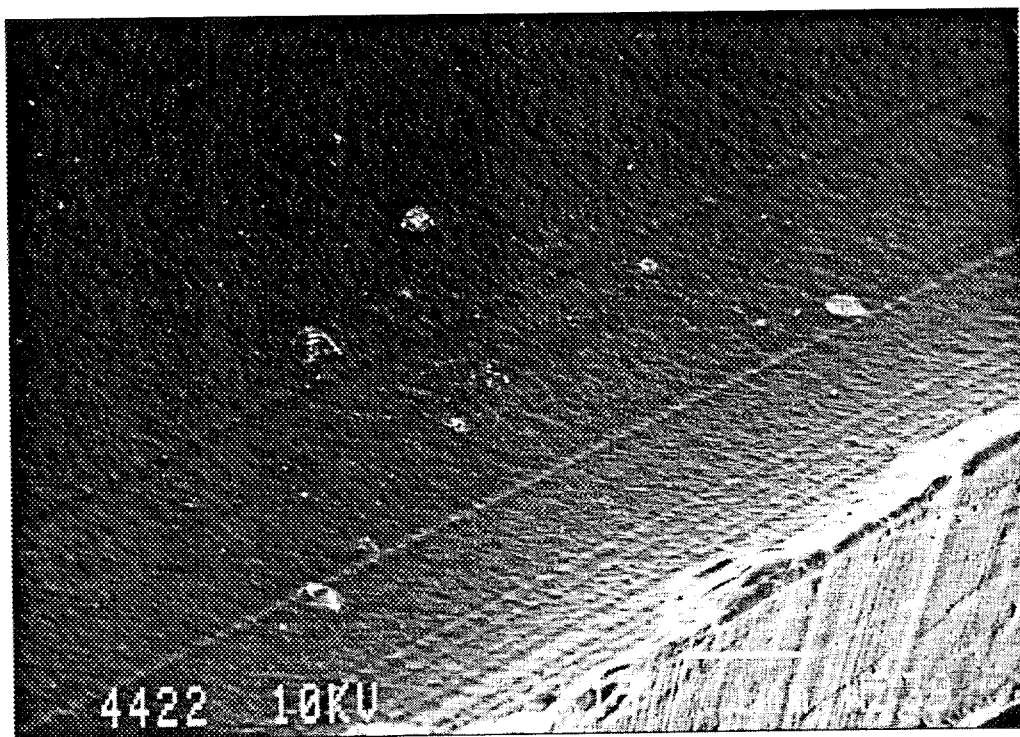
An examination of the ID of the Hamlin sample indicated several small holes as shown in Figure 6 (photo ID 4422). The number of these holes was of the same order of the holes seen in the microtomed OD section, implying that there did not appear to be any significant branching. Figure 7 (photo ID 4421) is an enlarged (350X) view of one of the holes at the ID. It appears to have a "cap" covering the hole, as has been found in several of the field leaks from Tennessee. Figure 8 (photo ID 4425) shows another of the ID holes at high magnification (1000X). The focus is on the interior of the hole and the surface is out of focus. The hole diameter appears to be about 35 to 50 microns. A view of the same hole from a different perspective and at a different magnification (750X) is shown in Figure 9 (photo ID 4423).

Figure 6. ID of Hamlin sample (15X)

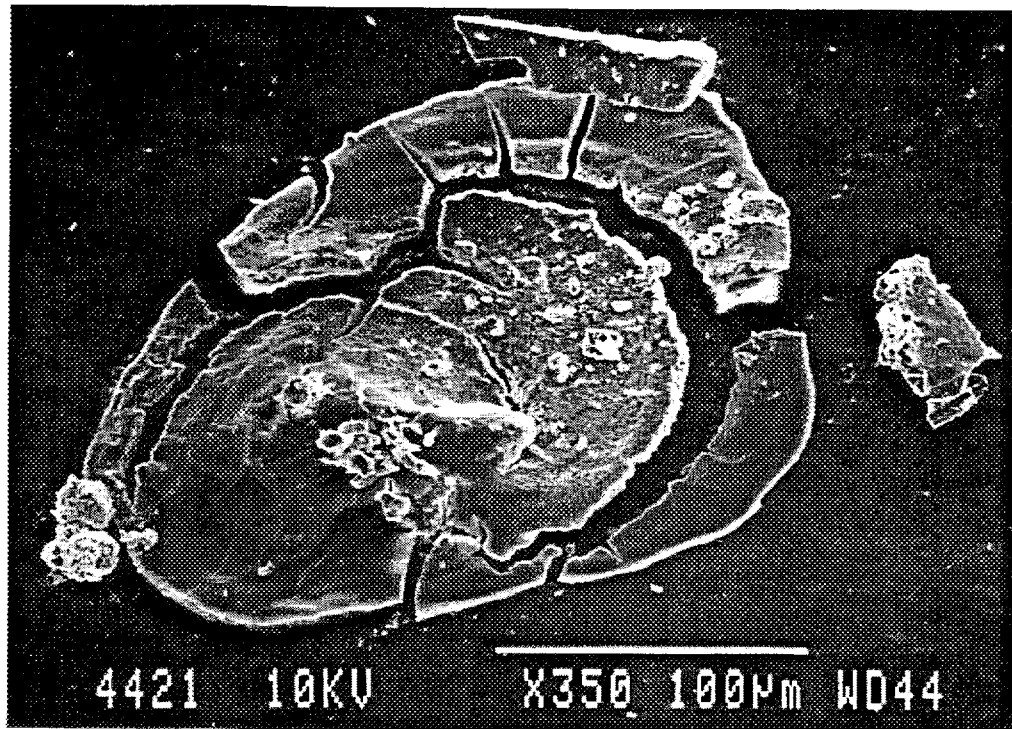
Figure 7. Enlarged view of one hole at ID (350X)

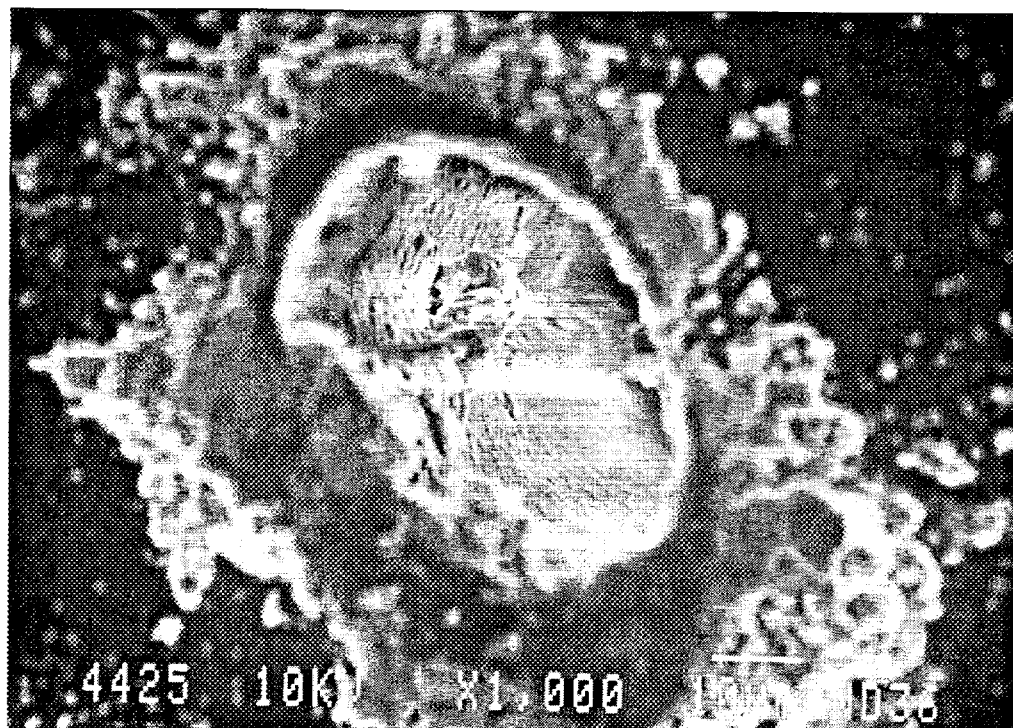
Figure 8. High-magnification view of hole at ID (1000X)

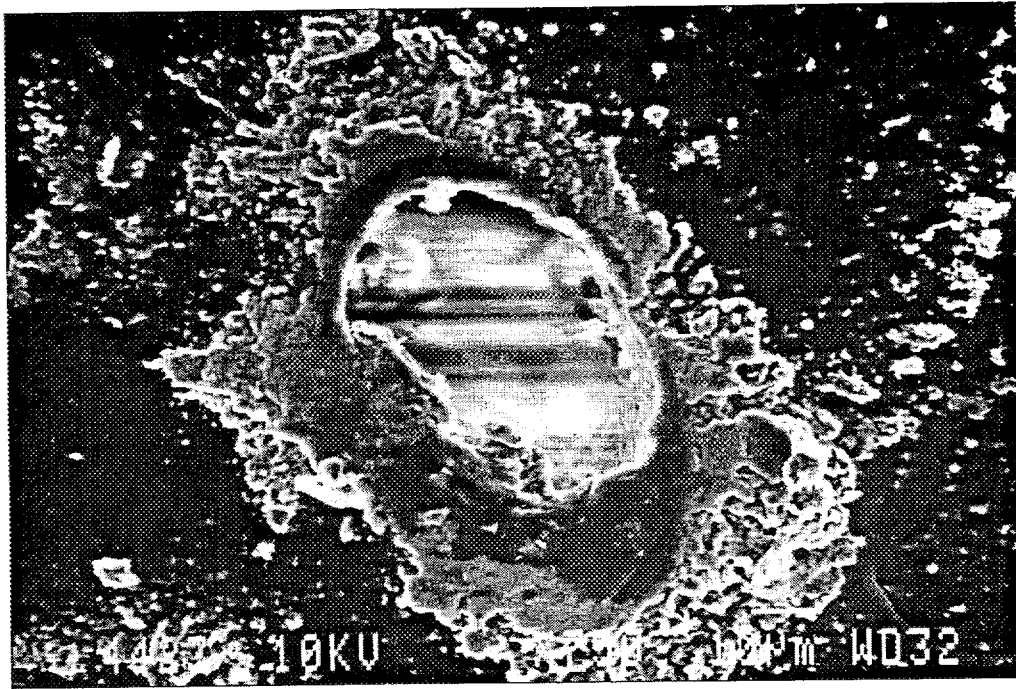
Figure 9. Different view of hole shown in Figure 8 (750X)

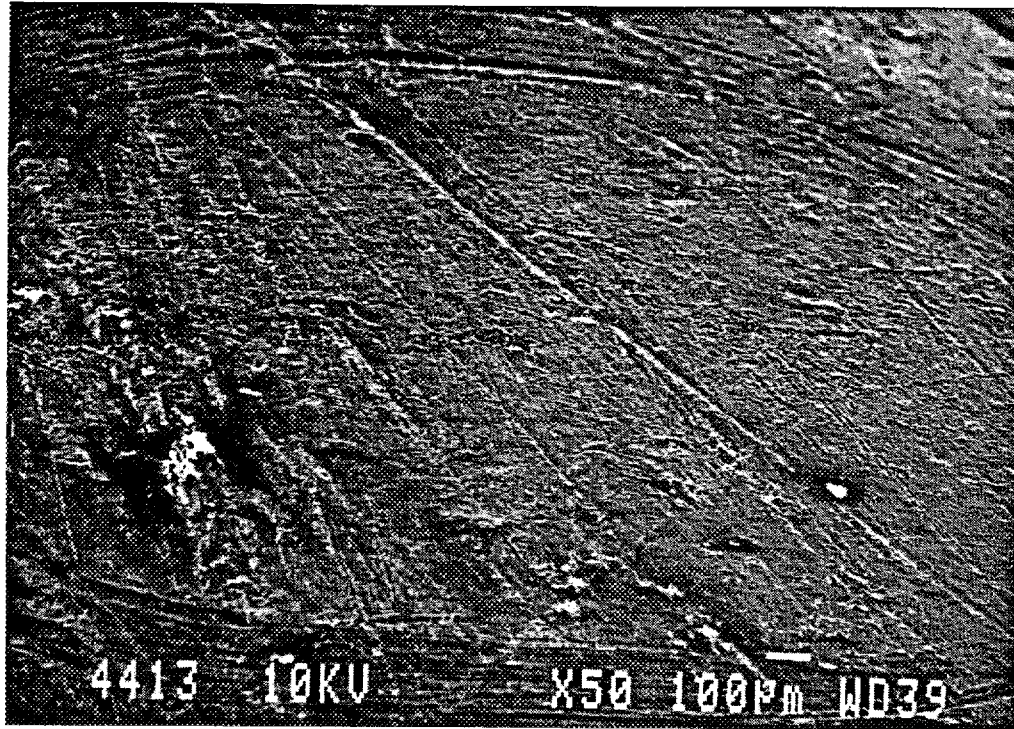
The OD of the Cornwallis sample at low magnification (50X) is shown in Figure 10 (photo ID 4413). The features of the leak site at greater magnifications (350X and 750X) are shown in Figures 11 (photo ID 4415) and 12 (photo ID 4416). The hole is visually similar to several of the Tennessee field leaks.

Figure 10. OD of Cornwallis sample (50X)

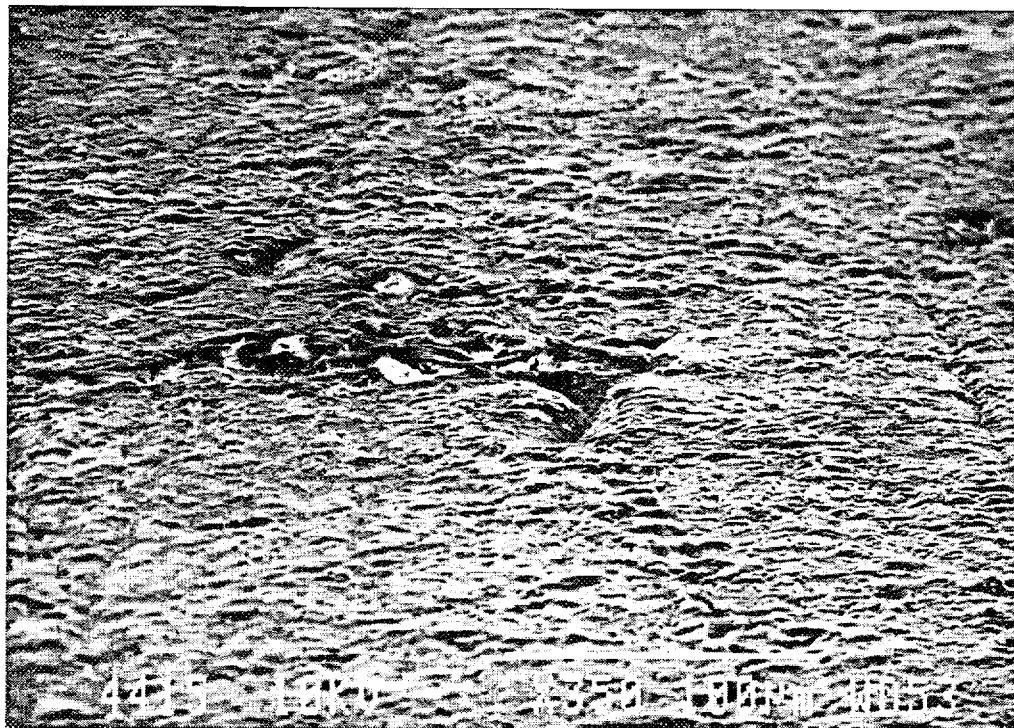
Figure 11. Leak site of Cornwallis sample (350X)

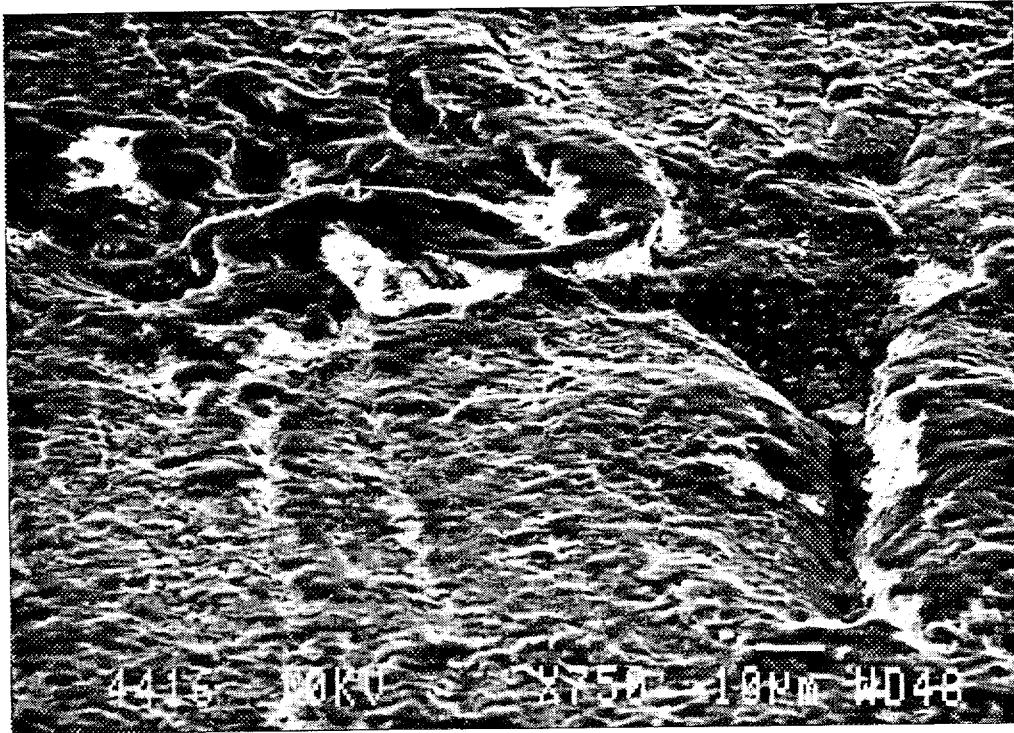
Figure 12. Leak site of Cornwallis sample (750X)

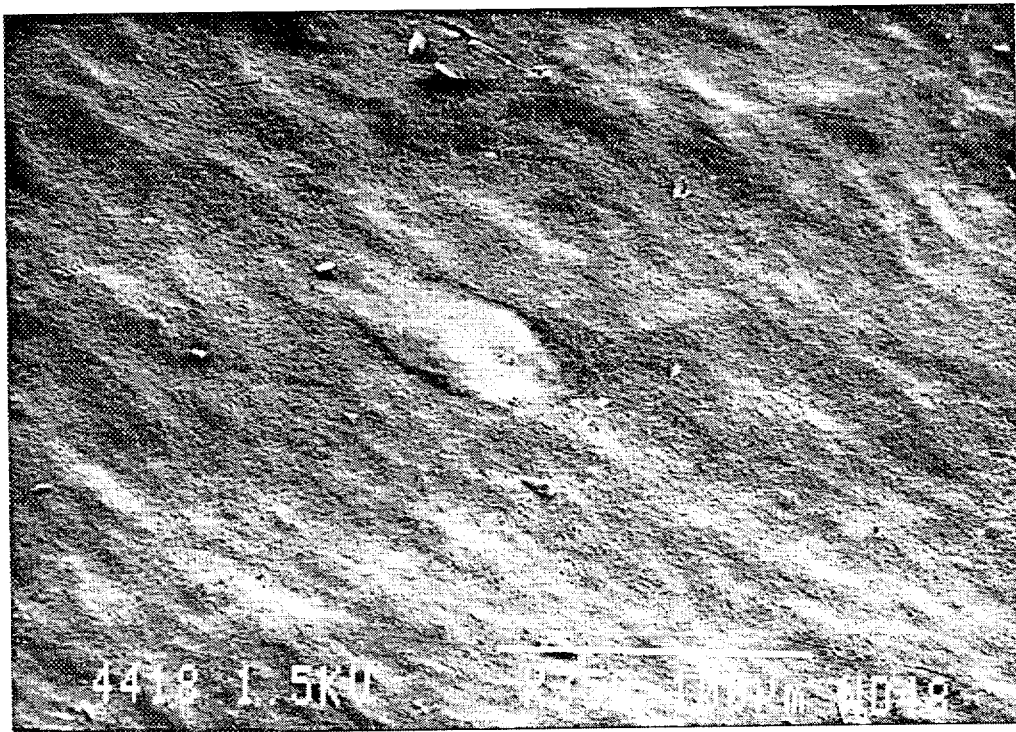
Figure 13. ID of Cornwallis sample leak site (350X)

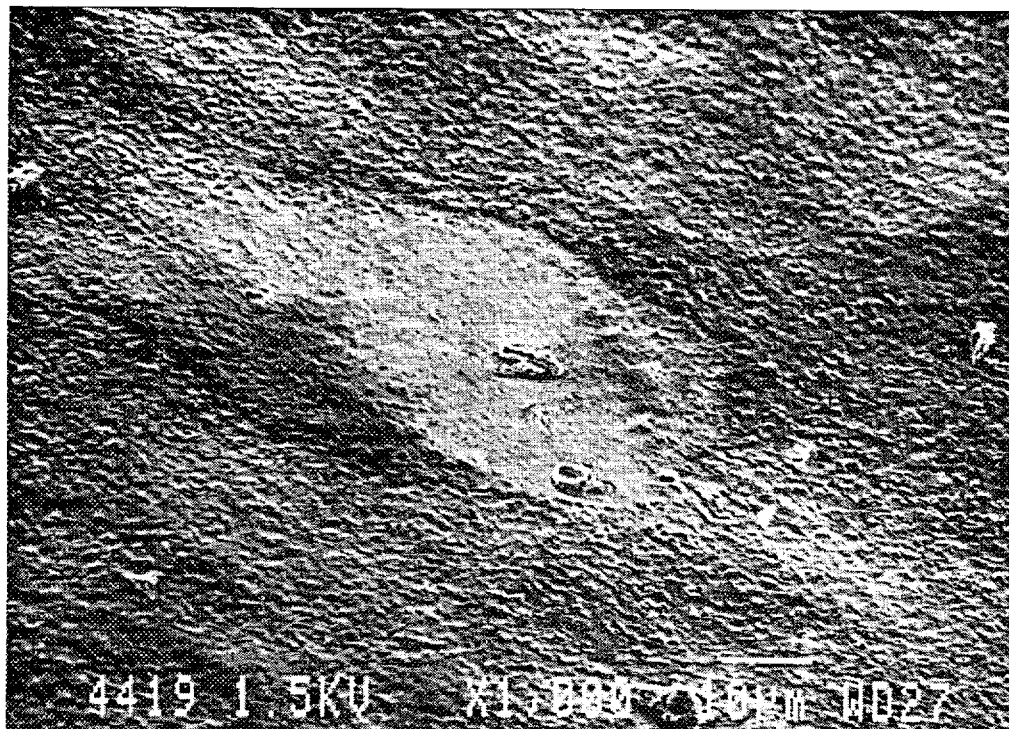
Figure 14. Enlarged view of Cornwallis sample leak site (1000X)

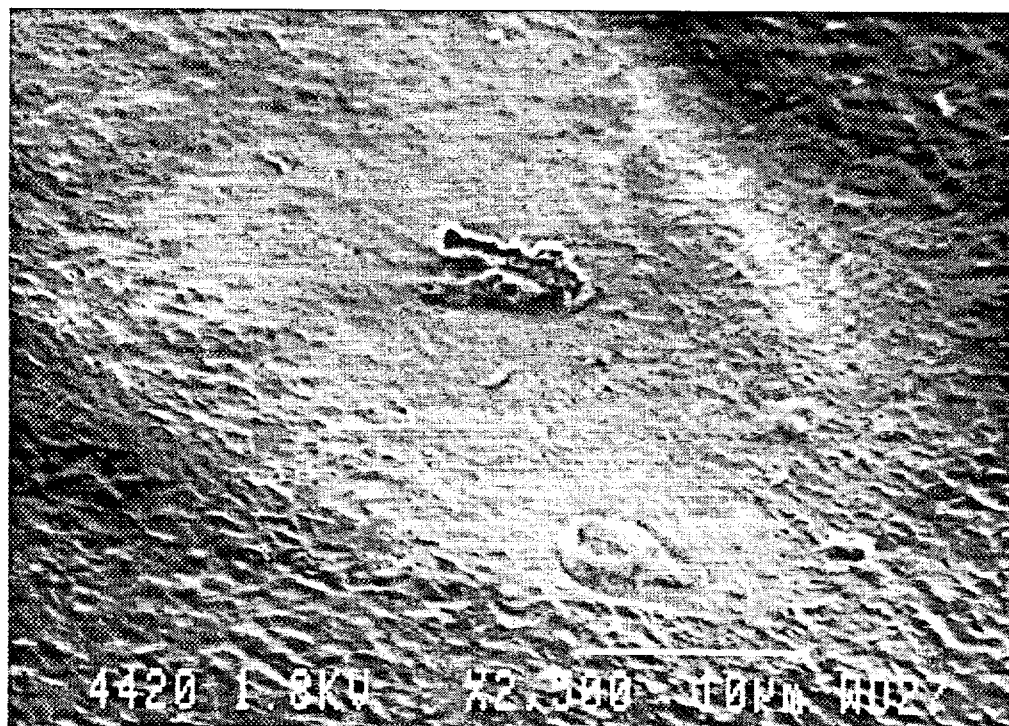
Figure 15. High-magnification view of leak site (2500X)

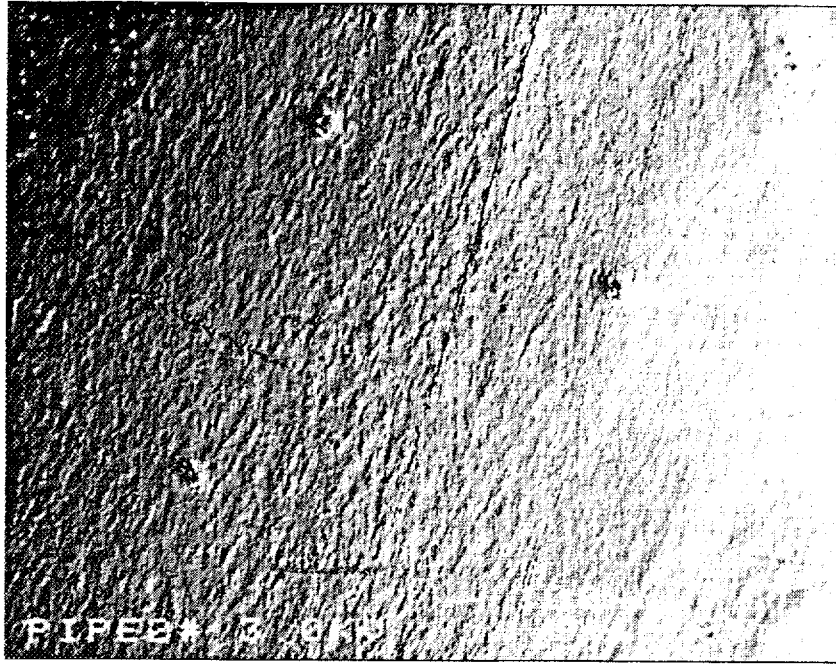
Figure 18. Three pinholes on outside surface (U. of Pennsylvania)

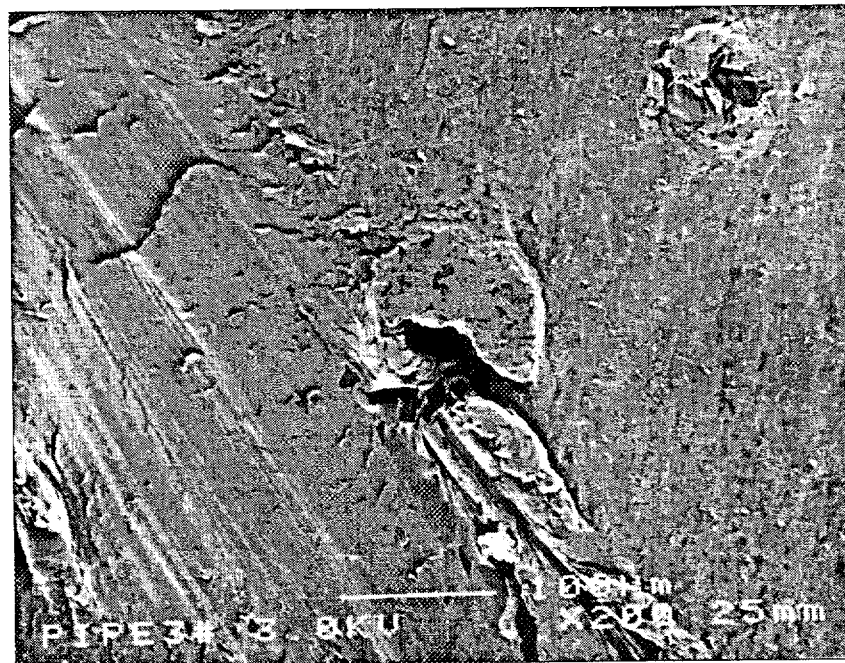
Figure 25. View of a small probable leak on outside of pipe (U. of Pennsylvania)

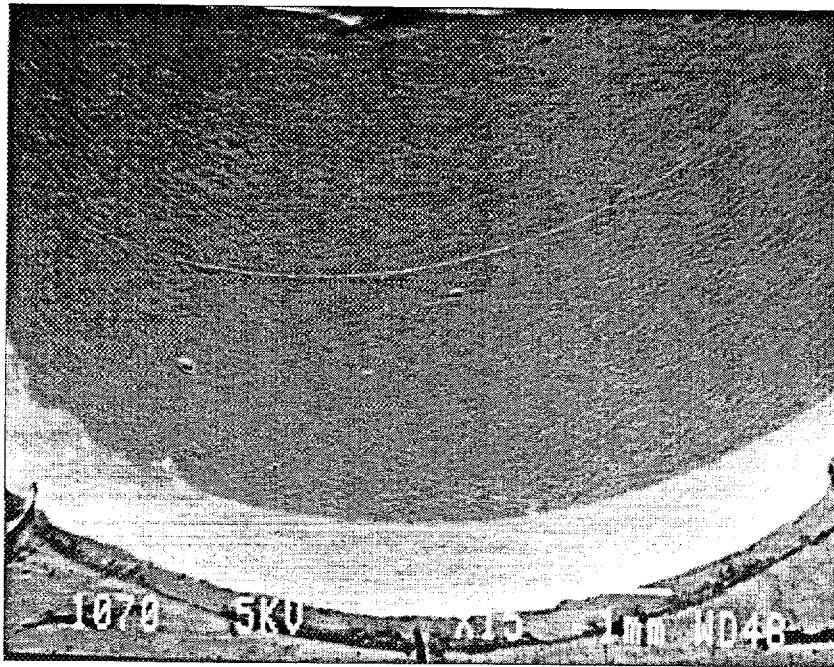
Figure 36. Two pinholes at inside diameter of pipe

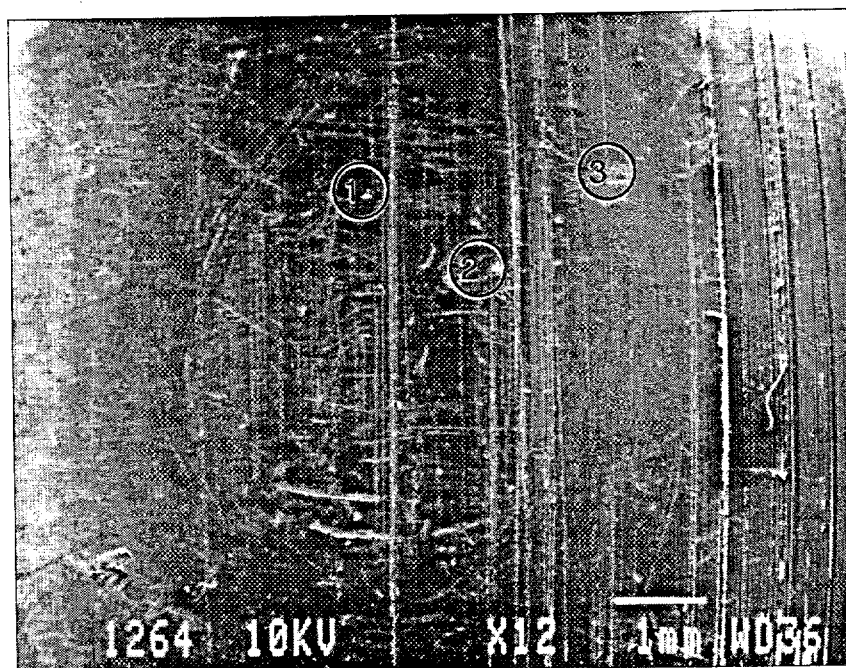
A low-magnification (12x) overview of P5-A at the OD (outer diameter) of the pipe is shown in Figure 45 (photo ID 1264). The areas marked 1, 2, and 3 are possible pinholes. The reason for the uncertainty is that the holes are not distinctive. Figures 46, 47, and 48 (photo IDs 1265, 1268, 1269) show the marked areas at greater magnifications. The composition of a particle in area 2 was analyzed and found to be mainly silicon and aluminum. This particle was on

Figure 45. Overview of P5-A at OD (12X)

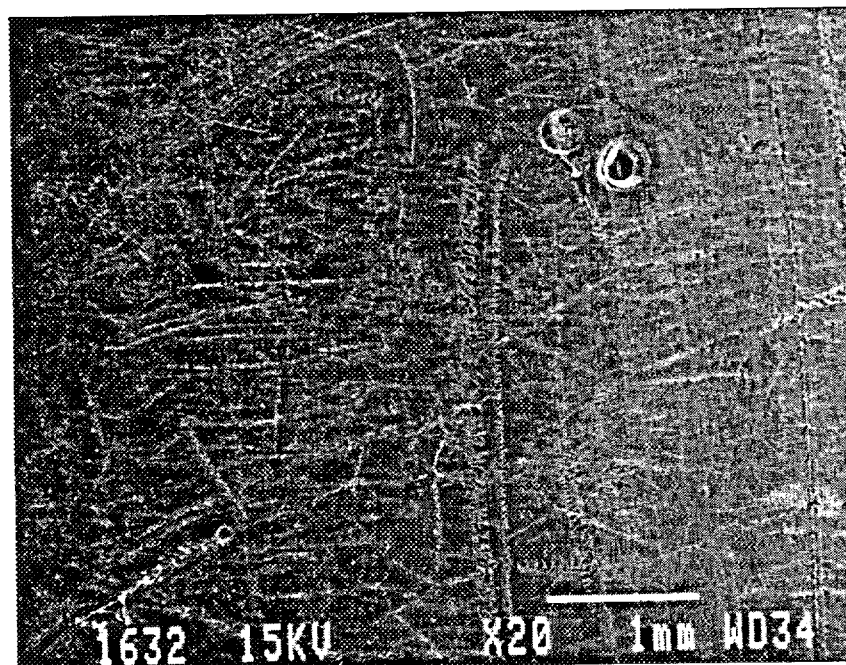
Figure 69 (photo ID 1632) shows the OD (outer diameter) of the pipe sample used in the discharge experiments at low magnification (20X). Two holes are visible. The larger hole is on the upper right with an adjacent circular mark. The smaller hole is on the lower left with an adjacent linear gouge. Magnified views (100X) of the larger and smaller holes are shown in Figure 70 (photo ID 1633) and Figure 71 (photo ID 1634) respectively. Figures 72 (photo ID 1635) and 73 (photo ID 1637) show the small hole in two views at 600X magnification. Figure 74 (photo ID 1638) shows the smaller hole at a magnification of 2000X. The holes are quite “clean” in

Figure 69. Outer diameter of pipe sample at low magnification (20X)

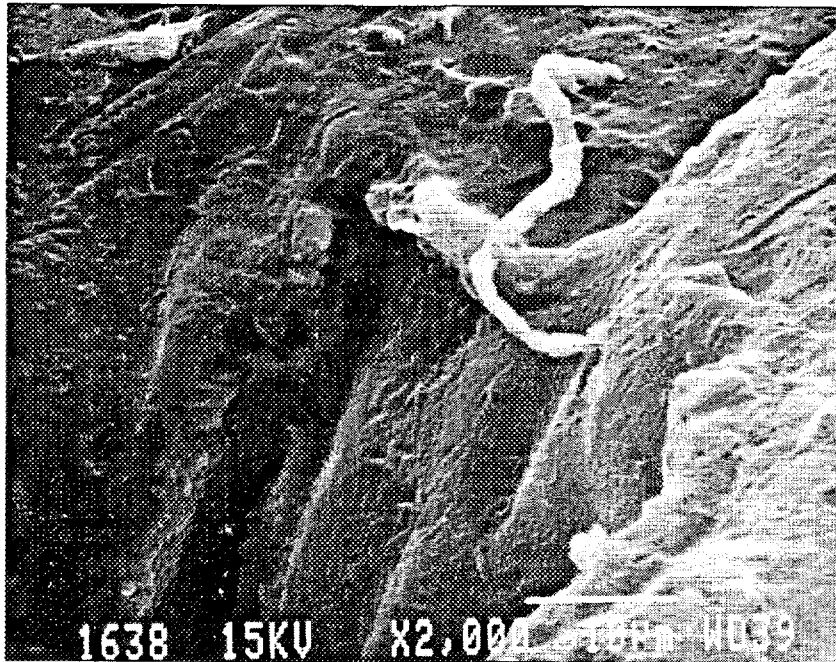
Figure 74. View of smaller hole in Figure 69, magnified 2,000X

not having fibrils covering the holes. The size of the holes is 80 to 120 micrometers. Both these characteristics are typical of high-voltage discharges and are not typical of the pinholes observed in pipe from the field. Figure 75 (photo ID 1640) shows a low-magnification (75X) view of the hole at the ID (inner diameter). The hole is surrounded by an area in which surface features are absent, as if local melting had occurred. Another view at higher magnification (350X) is shown in Figure 76 (photo ID 1641). Again, the features suggest local melting.

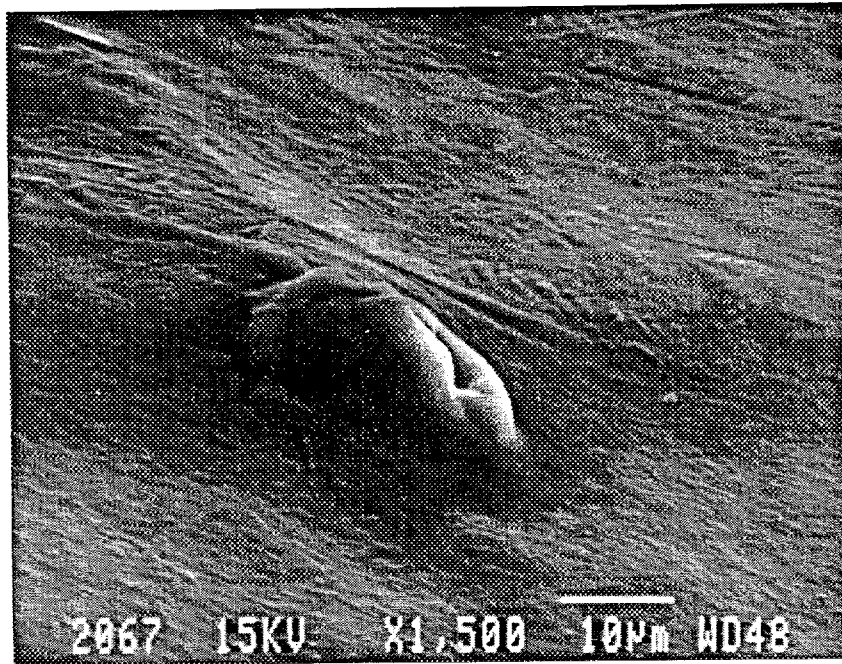
Figure 85. Features of pipe sample suggest local melting and resolidification

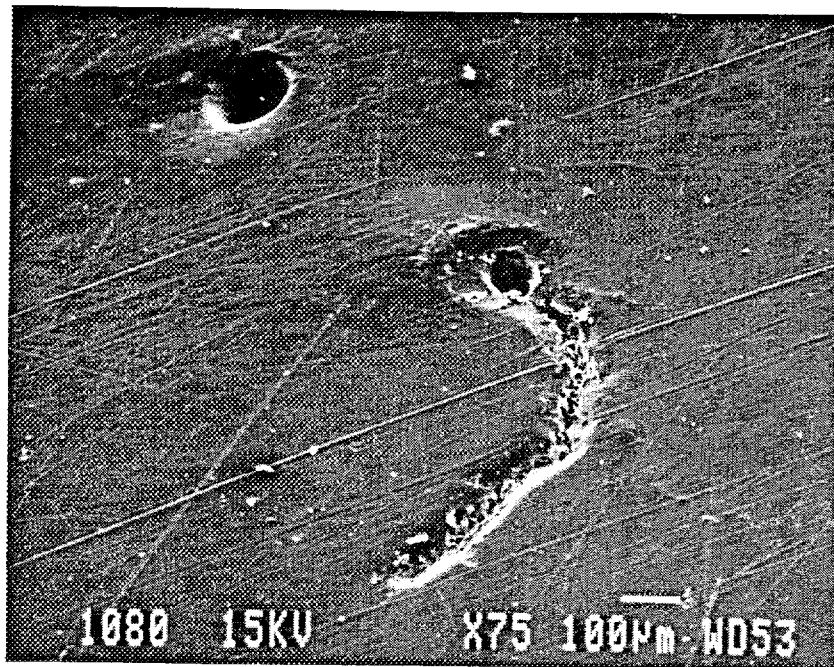
Figure 101. Holes in disk provided by Union Carbide

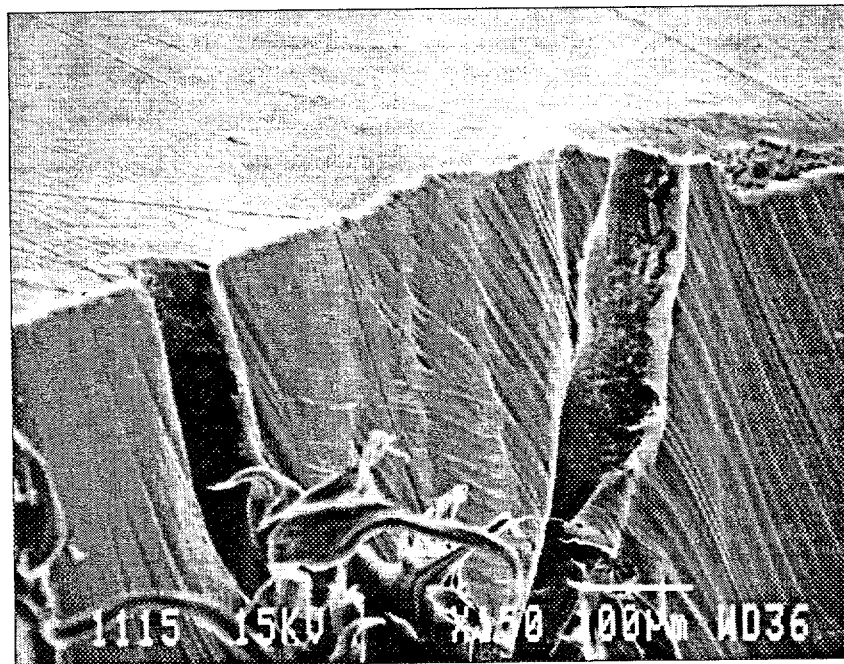
The disk was immersed in liquid nitrogen for about one half hour, and then fractured with the hope that the fracture plane would follow the hole for some distance. One half of the fractured disk is shown in Figure 107. The entrance surface of the disk is vertical on the right-hand side. The exit surface of the disk (with the two holes) is vertical on the left-hand side. The branching from the one entrance hole to the two exit holes can be clearly seen. The entire passage seems "clean" in the sense referred to earlier. Another view of the exit holes is seen in Figure 108.

Figure 108. Two holes on exit surface of fractured disk

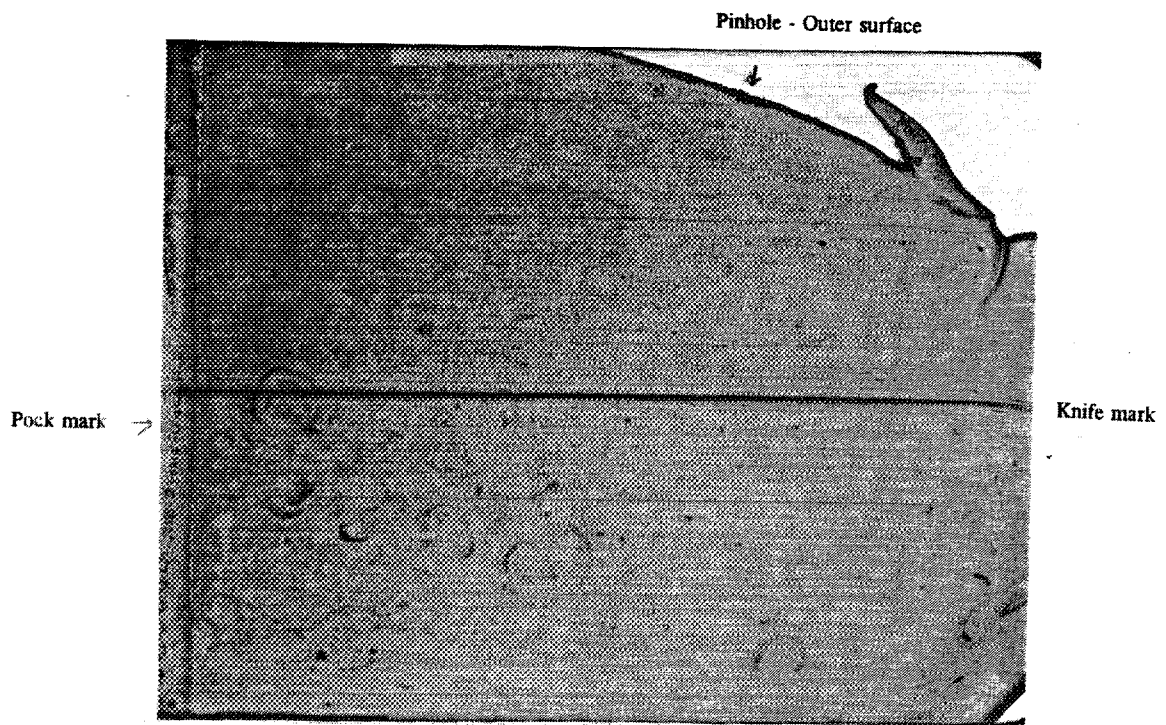
The sections were first examined under an optical microscope using transmitted light. Figure 1 shows a typical micrograph of the specimen oriented in the direction perpendicular to the axis of the pipe. The micrograph appears to be spotty (i.e., it has "pock marks" or "lenses") instead of being clear. The length scale of these pock marks is about 200 μm . When these sections were examined at higher magnification (200x), the pock marks appear to have distinct boundaries (see Figure 2). The regions interior to the pock marks sometimes have dark spots. The center of some pock marks has a distinct circular region. The

**FIGURE 1. OPTICAL MICROGRAPH OF MICROTOMED SECTIONS SHOWING
POCK MARKS**

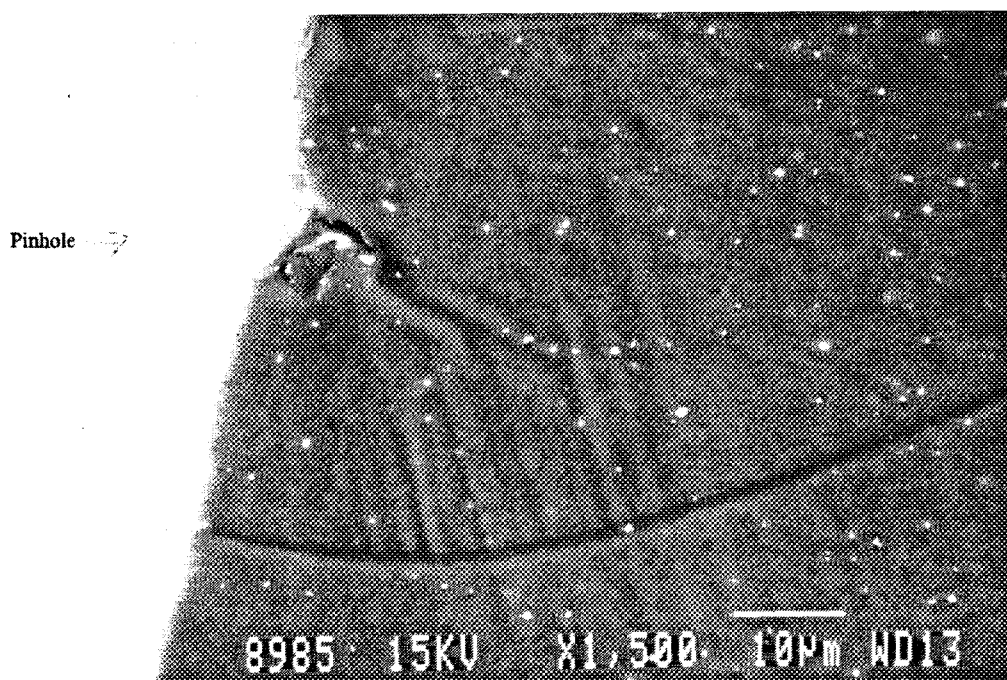
**FIGURE 5. MICROTOMED SECTION SHOWING PINHOLE ON THE LEFT**

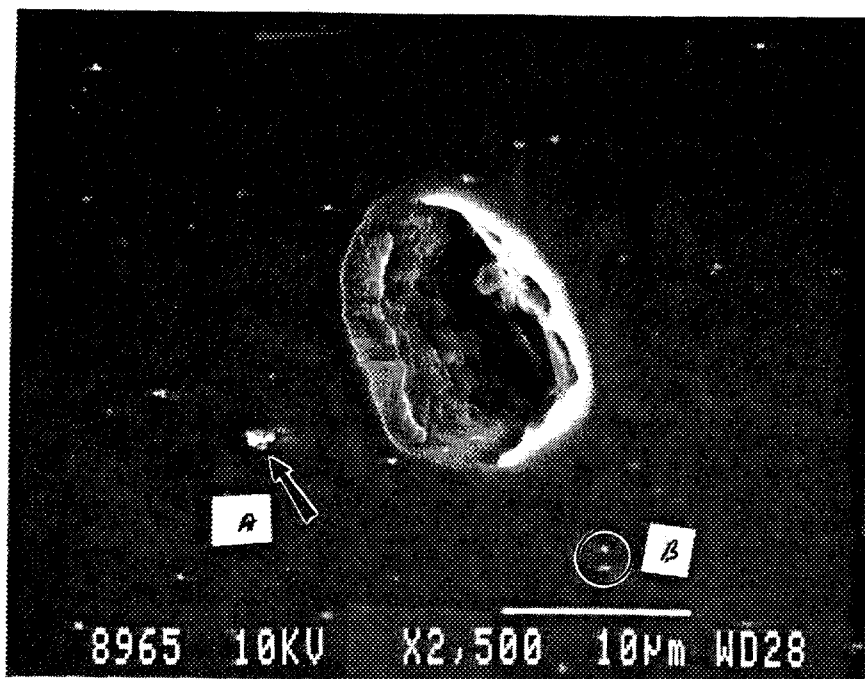
FIGURE 6. SCANNING ELECTRON MICROGRAPH OF THE MICROTOMED SECTION AWAY FROM THE PINHOLE SHOWING A LARGE INCLUSION ACCOMPANIED BY SMALL WHITE SPOTS A AND B
