GTI Laboratories
1700 S. Mt. Prospect Road
Des Plaines, Illinois 60018

**Static Discharge Failure of PE Pipe
for
Connecticut Natural Gas Corp.**

May 5, 2003

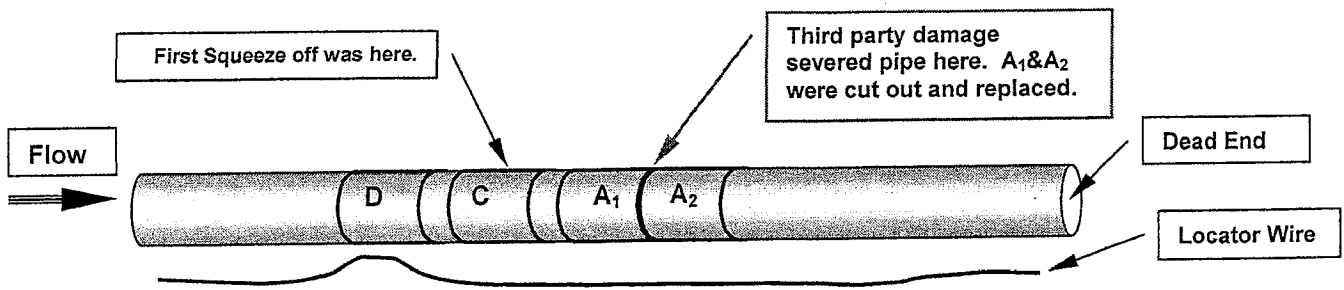
Fig. 1. Schematic of failure samples relative to pipe segment.

Sample	Location And Description
A ₁	Portion of pipe severed by third party.
A ₂	Mating portion of pipe severed by third party.
C	Pipe segment containing first pinhole, pinhole 1 (at squeeze-off point).
D	Pipe segment containing second pinhole, pinhole 2 (at point near tracer wire).

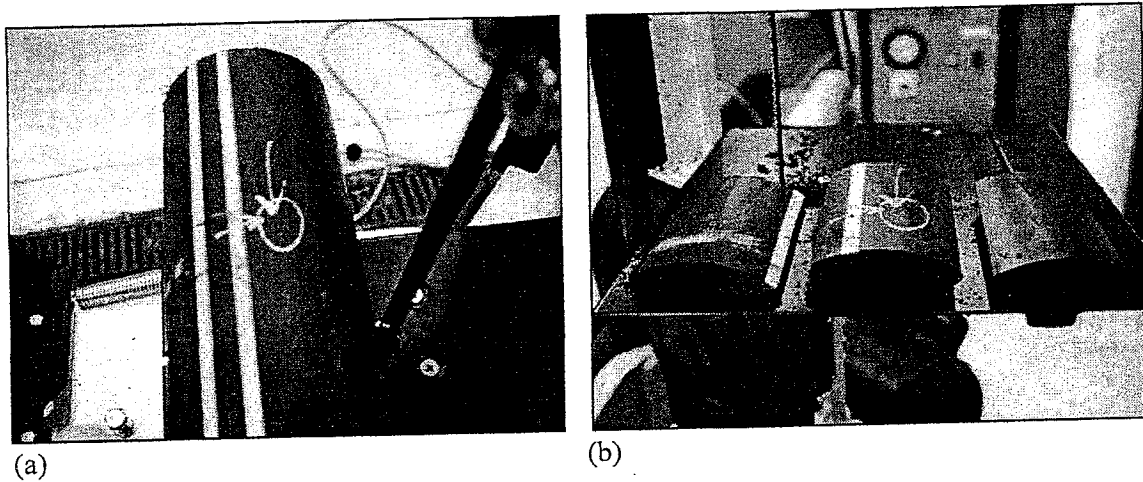
Fig. 5. Example of sectioning of pipe to allow stereo-optical and scanning electron microscopy of all surfaces (a,b).

At GTI, the pipe segments C and D were photographed with a digital camera, and then sectioned with a band saw to reveal their inner surfaces, see Fig. 5.

The inner and outer surfaces of each section were then analyzed using stereo-optical microscopy and scanning electron microscopy (SEM). Pinholes and evidence of mechanical damage were located on both the inside and outside surfaces of the pipe sections. The inside of the PE pipe was covered with sand and dirt debris and there were particle impingements on the inside of both segments, see Figs. 6 and 7.

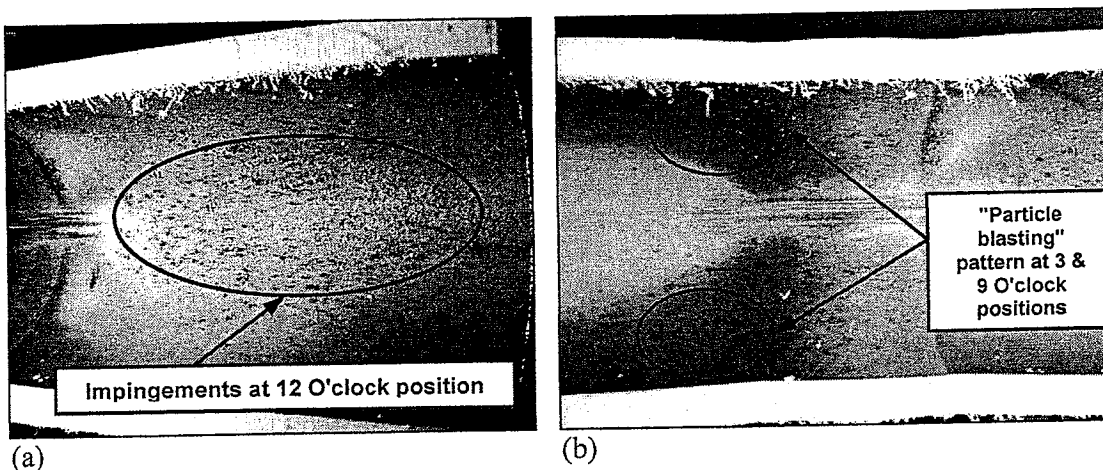
Fig. 8. Squeeze off morphology and impingement in a yellow PE pipe provided courtesy of Performance Pipe Company⁸ (i.e., not the CNG pipe). (a). Wrinkle and impingement pattern shows high rates of particle deposition at the 12 O'clock position downstream of the squeeze off (b). "Particle Blasting" of the pipe is also evident upstream of the squeeze off, maximized at the 3 and 9 O'clock positions (areas of maximum squeeze off. This pattern is typical of a line which is squeezed off and then reopened without being equalized first by a bypass and valve arrangement.
