Electrostatic Pinholing in PE Service Lines

By Ray A. Ward, Gas Systems Engineer, Memphis Light Gas and Water and Dirk Smith, President, Ionix Technologies Inc.

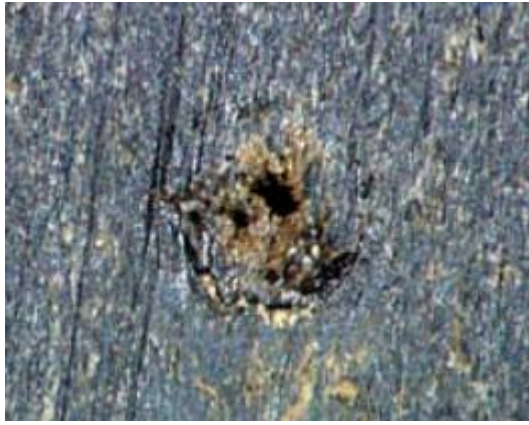
Investigation by the pipe manufacturer revealed numerous pinholes throughout the damaged pipe. Sectioning the pipe under a light microscope the pipe manufacturer documented a channel through the pipe wall. The pipe samples were section cut under a microscope. The shape or characteristic of the pinhole channel was consistent with electrostatic pinholing.

Interior pinhole of damaged pipe
