Topical Report

Analysis of Microscopic Leaks in Polyethylene Gas Distribution Piping

September 1996

REPORT DOCUMENTATION PAGE	1. REPORT NO. GRI-96/0014	2.	3. Recipient's Accession No.
4. Title and Subtitle Analysis of Microscopic Leaks in Polyethylene Gas Distribution Piping			5. Report Date September 1996

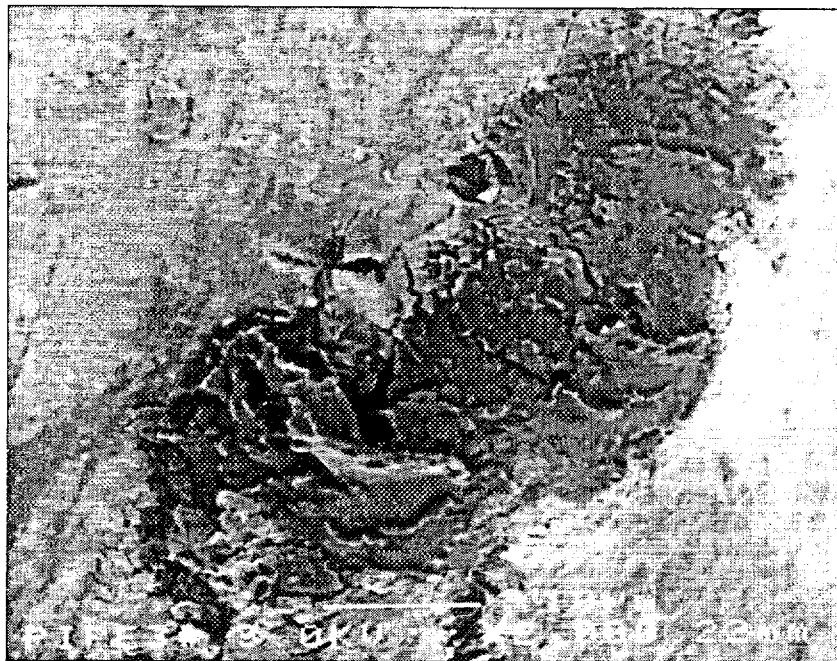
Professor Norman Brown of the University of Pennsylvania examined a tubing sample that was sent to him by Battelle at GRI's request and a sample sent to him directly by UCG. The resulting photographs are shown in Figures 18 through 27. Figures 18 through 21 and Figures 25 through 27 refer to the sample from UCG, while Figures 22 through 24 refer to the sample from Battelle. Figure 18 shows the outside of the pipe with a cluster of three holes. A matching cluster of three holes was found on the inside surface, indicating that there was no "branching" of the holes. Figure 19 shows the inside surface of one of the pinholes. Figure 20 shows a fibrilla surface of the inside wall of the hole at a magnification of 3000X. Figure 21 shows the outside surface of the same hole. Figure 22 shows a pinhole at the inside diameter. Figure 23 is an enlargement of Figure 22. Figure 24 is the same view using backscattered electrons. Figures 25 through 27 are views of a possible leak about 6 inches away from the cluster of three holes.

Figure 27. View of the pinhole in Figure 25 at inside surface of pipe

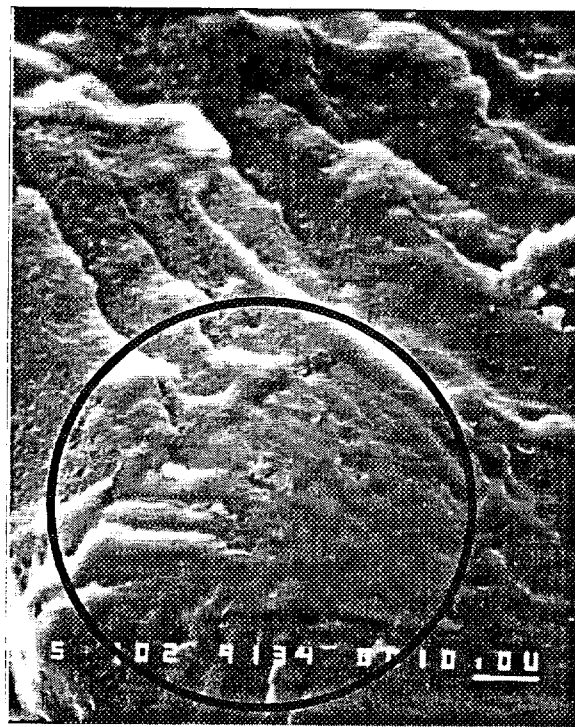
Figure 40. 1000X view of same area as in Figure 39 using conventional electron scattering

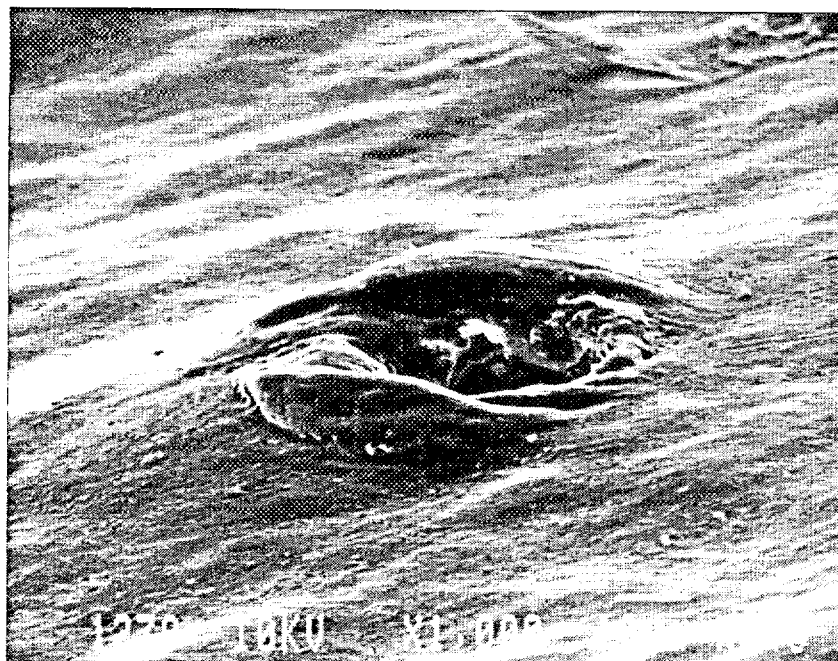
Figure 54 (photo ID 1270) shows a low-magnification overview of the outer diameter of the pipe at P5-B. Figures 55 (photo ID 1271) and 56 (photo ID 1272) show enlarged views of the areas marked "1" and "2" in Figure 54, respectively. One hole was visible on the inside diameter. Three views of this hole on the inside diameter are shown in Figures 57 (photo ID 1279), 58 (photo ID 1278), and 59 (photo ID 1280) at increasing magnifications.

Figure 57. Hole on ID of P5-B (500X)

Figure 58. Hole on ID of P5-B (1000X)

Figure 59. Hole on ID of P5-B (2500X)

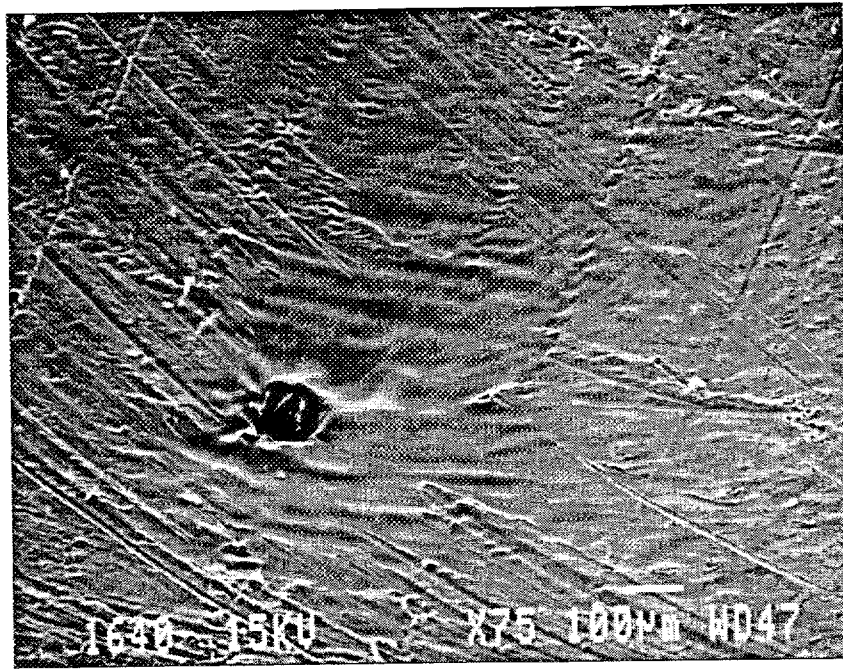
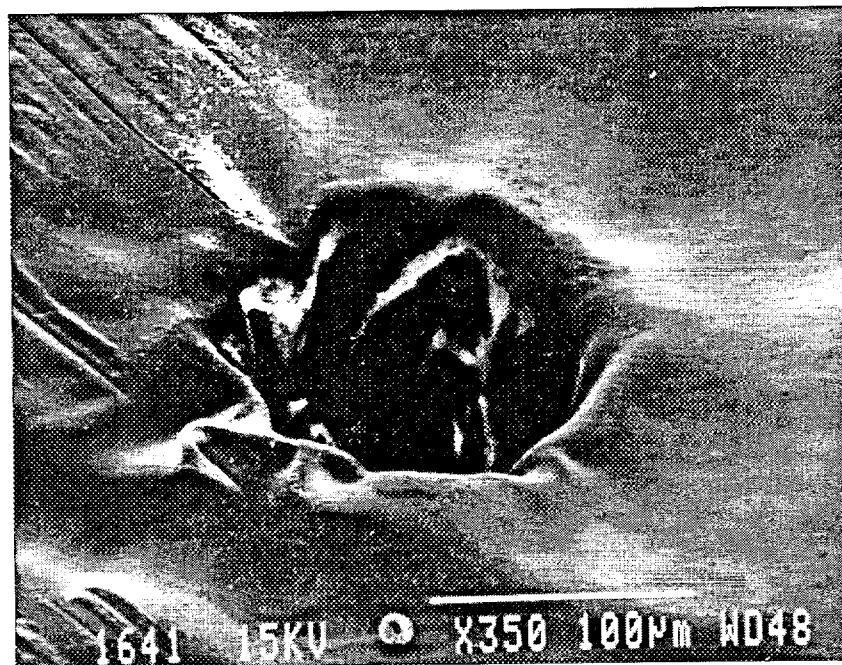
not having fibrils covering the holes. The size of the holes is 80 to 120 micrometers. Both these characteristics are typical of high-voltage discharges and are not typical of the pinholes observed in pipe from the field. Figure 75 (photo ID 1640) shows a low-magnification (75X) view of the hole at the ID (inner diameter). The hole is surrounded by an area in which surface features are absent, as if local melting had occurred. Another view at higher magnification (350X) is shown in Figure 76 (photo ID 1641). Again, the features suggest local melting.

Figure 75. Inner diameter of pipe sample at low magnification (75X)

Figure 76. View of hole in Figure 75, magnified 350X
